Signal Integrity Analysis Autonomous Valet Parking System

Scope : Signal Integrity Analysis

Application : Advanced Driver Assistance System (ADAS)

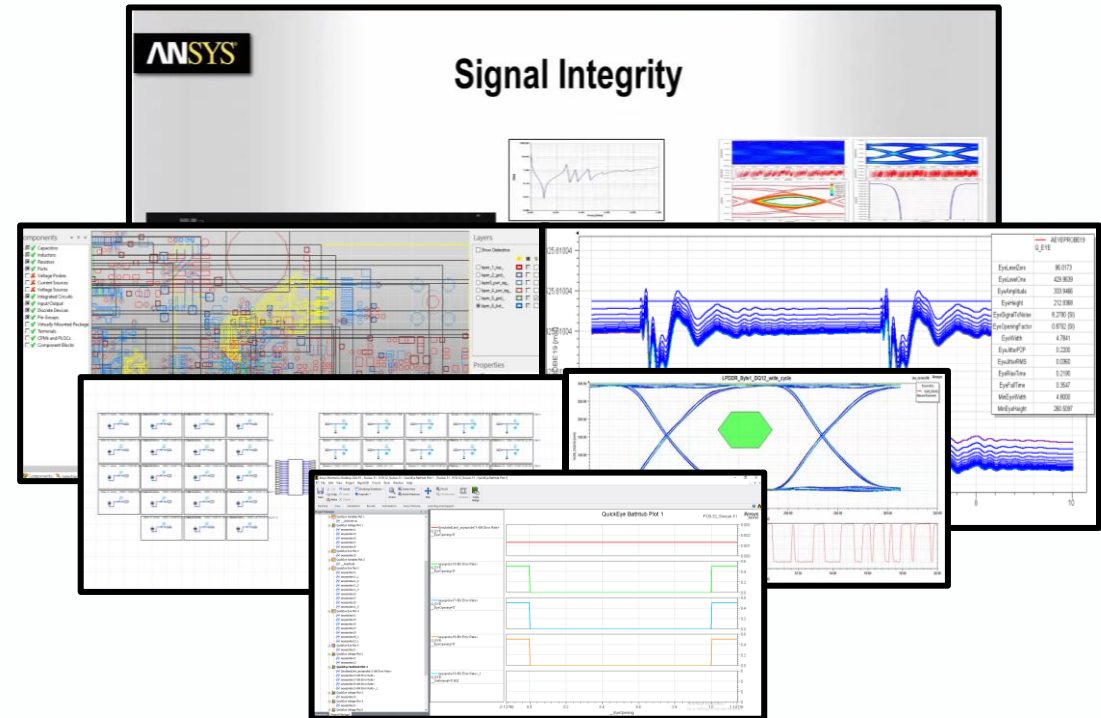
We executed the analysis in **Ansys-SI Wave** tool, to evaluate the signal integrity performance of the layout.

Quantities to calculate include:

- ✓ Edge Rate
- ✓ Characteristic Impedance
- ✓ Signal-to-Noise Ratio (SNR) Margin
- ✓ Timing Skew
- ✓ Simultaneous Switching Noise Impact

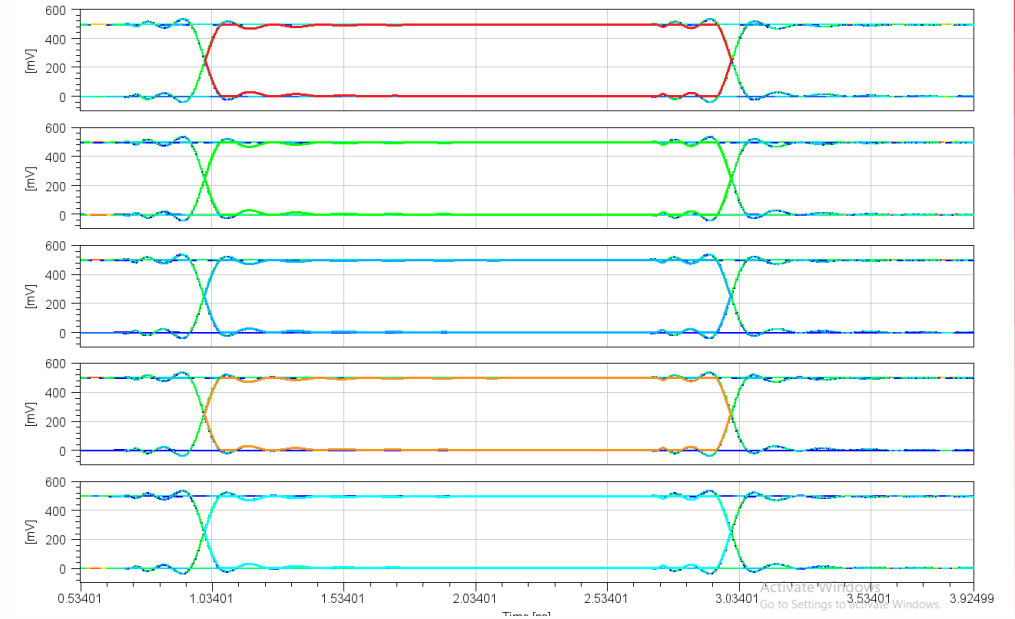
Quick-Eye Plot View

Analysis Result

Both the values are meeting the requirement and the results are **pass**.
