# Power Integrity Analysis for Videoscope system Board

**Scope :** Stable and Reliable Power Distribution Network

# Investigation of Power Circuit

# Analysis – Graphs and Results

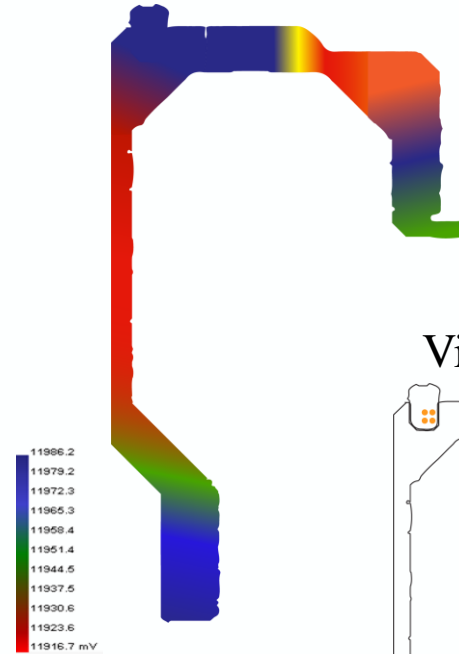
**Net Name: +3.3V**    Voltage: 3.3V    Current: 4A

Max. Voltage Drop – 5.00%

#	Measurement	Test	Constraint
	Filter	Filter	Filter
1	Max Voltage Drop	PASS	5.000%
2	Max Current Density	FAIL	100.00mA/mil <sup>2</sup>
3	Max Via Current	FAIL	1000.0mA

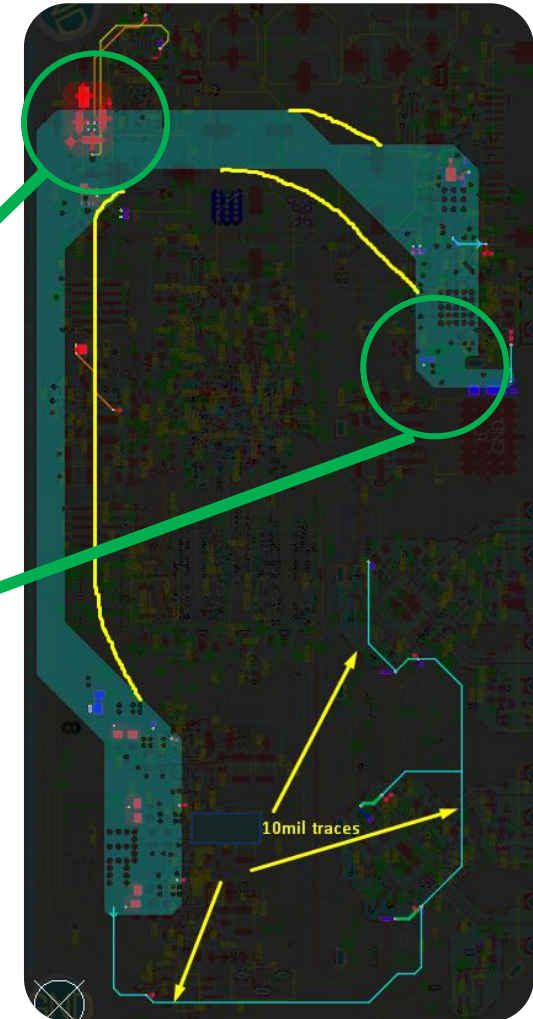
## Power Net : +3.3V

1. Increase the width of Cu pour at specified locations.
2. Increase the trace width in Layer 6 and Layer 8.
3. Add more vias to transfer power properly.

1. Increased the width of Cu pour.
2. Trace width increased on Layer 5 & Bottom Layer.
3. Vias added for proper transfer of power.

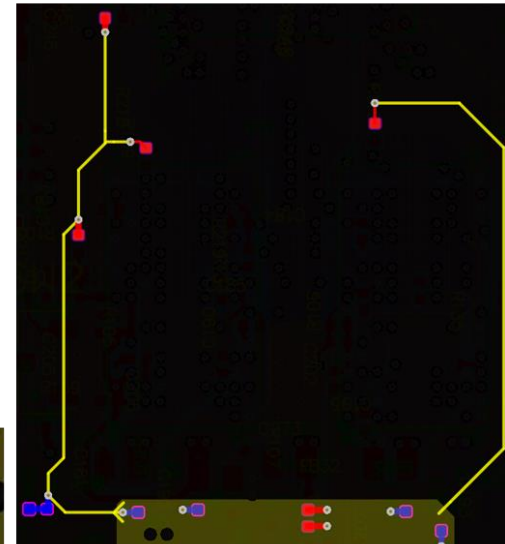
## Power Net : +1.5V

1. Trace width increased to 30mil on Layer 5.
2. Vias added at source point and near capacitor C73.

Trace widths are  
increased  
to 30 mil
